Manhole Inspection Summary

Manhole # S13MM1006MH

Insp Date: **12/6/06 9:10 AM**

Location Address: **3012 VIRGINIA AVE**

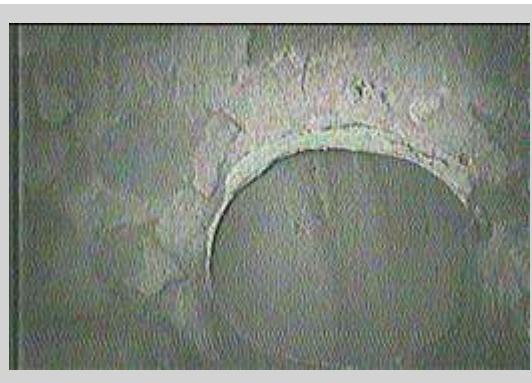
Drop In @ 6 O'Clock

Drop: **Outside** Rod and Bar

Angled: **Yes** Reading: **9.05** (ft.)

Inv Depth: **10.05** (ft.)

Drop Condition: **Open**

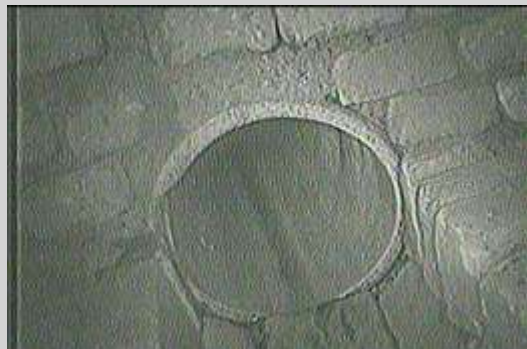
6 in. Circular Gravity Sewer

Pipe Material: **Clay**

Infiltration: **None**
